Asbestos Management Survey Report

Glatton Village Hall
High Haden Road
Glatton
Huntingdon
PE28 5RU

THIS MANAGEMENT SURVEY WAS COMPLETED ON 14/08/2020 AND THIS REPORT WAS COMPILED ON 13/08/2020
SITE REFERENCE POTGLA

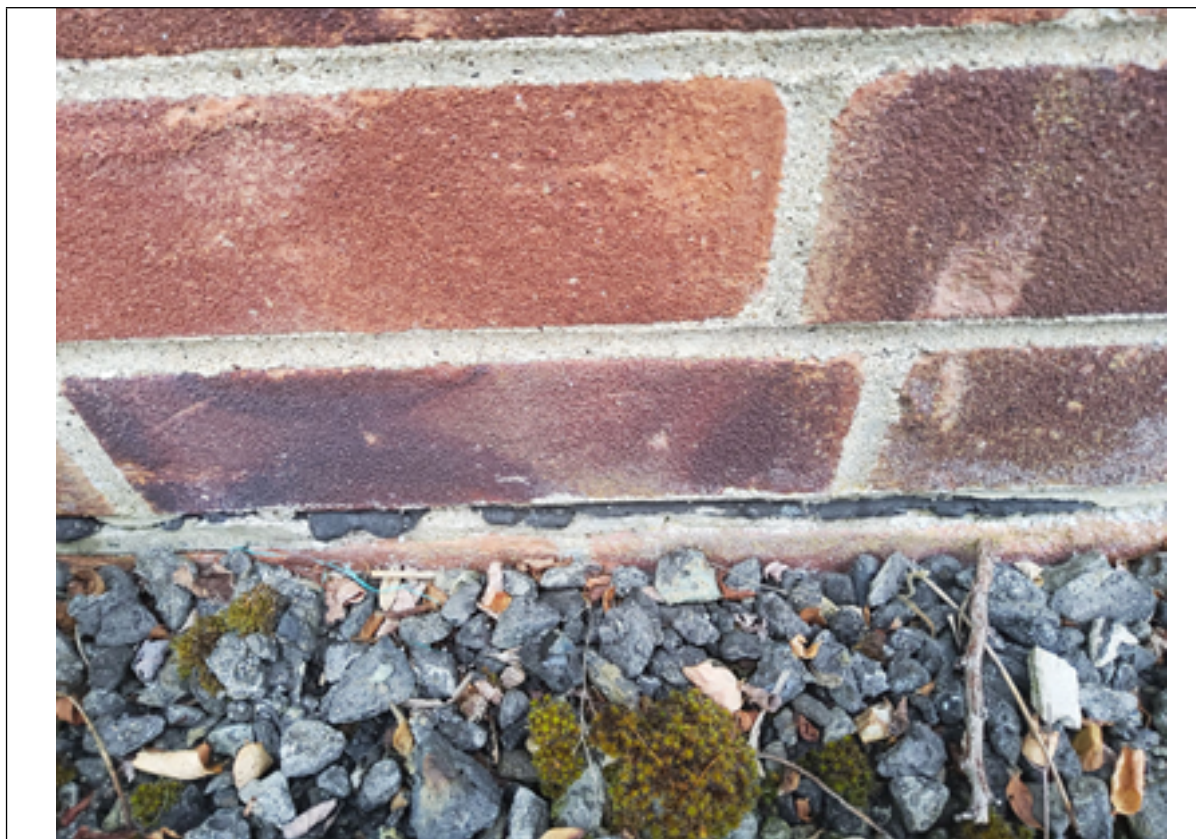
001

Asbestos Type	NADIS
Product Type	Damp Proof Course
Condition	Low Damage
Quantity	64 Metres (Length)
Surface Treatment	Bituminous
Material Risk Score	N/A

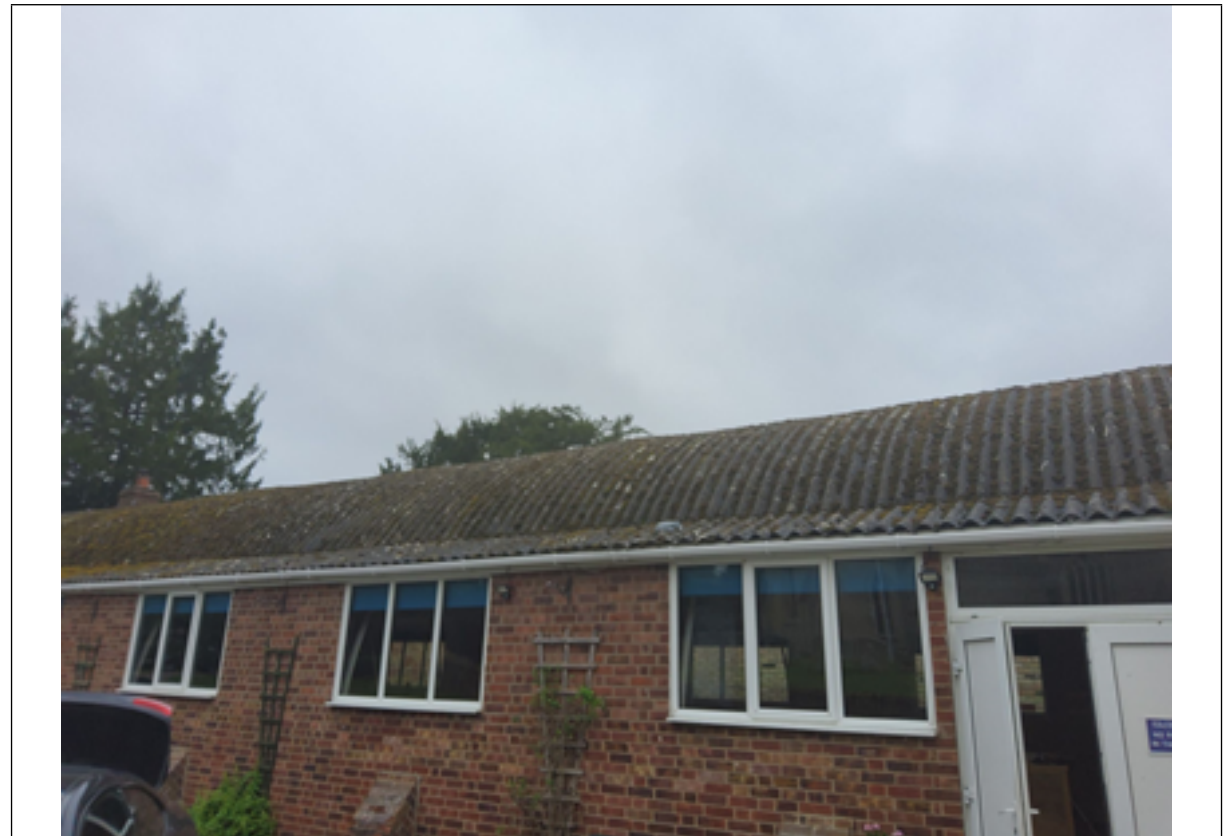
002

Asbestos Type	Chrysotile
Product Type	Cement Corrugated Sheet
Condition	Low Damage
Quantity	200 m2
Surface Treatment	Cement
Material Risk Score	4

These roof sheets contain Chrysotile asbestos and are in a low damage condition with signs of leaks. These should be managed via an asbestos management plan.

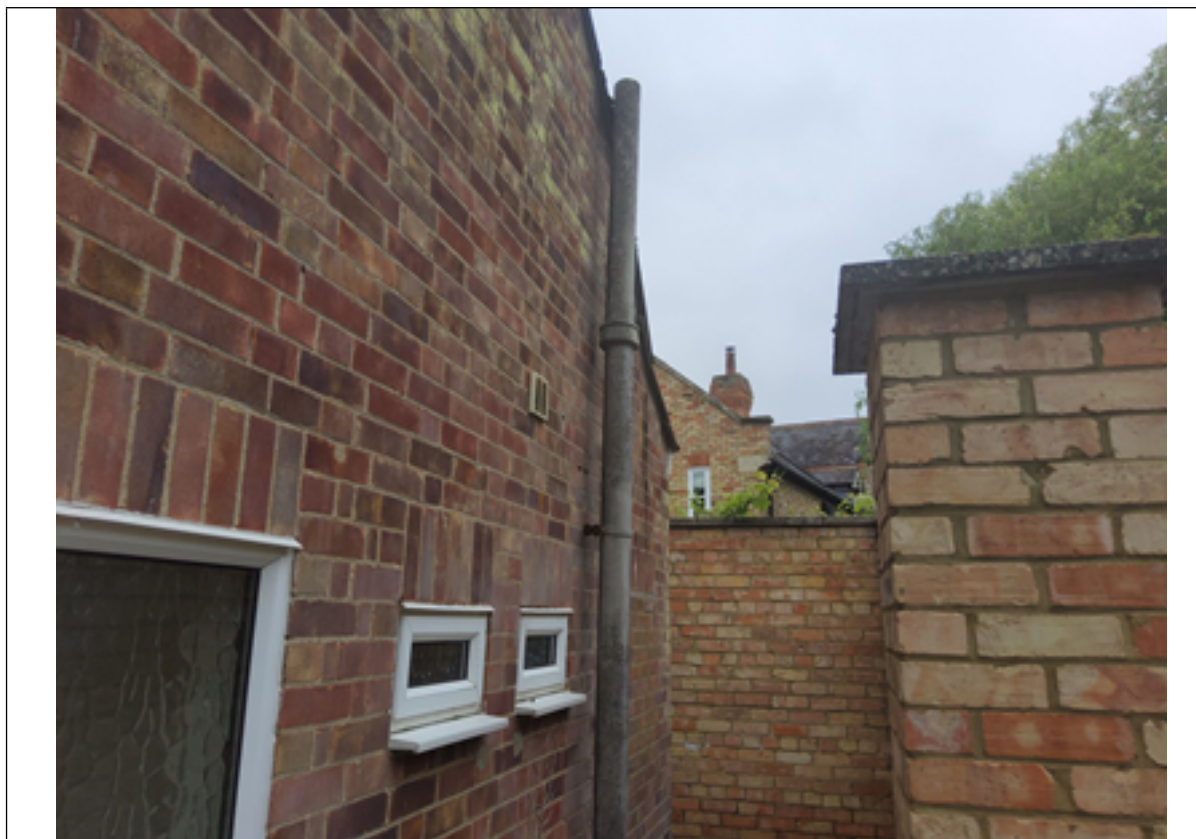
003

Asbestos Type	Chrysotile
Product Type	Cement Down Pipe
Condition	Low Damage
Quantity	4 Metres (Length)
Surface Treatment	Cement
Material Risk Score	4

This down pipe contains Chrysotile asbestos. Although in a low damage condition, it is loose and is recommended to be removed. Until practical to do so, this should be managed via an asbestos management plan.

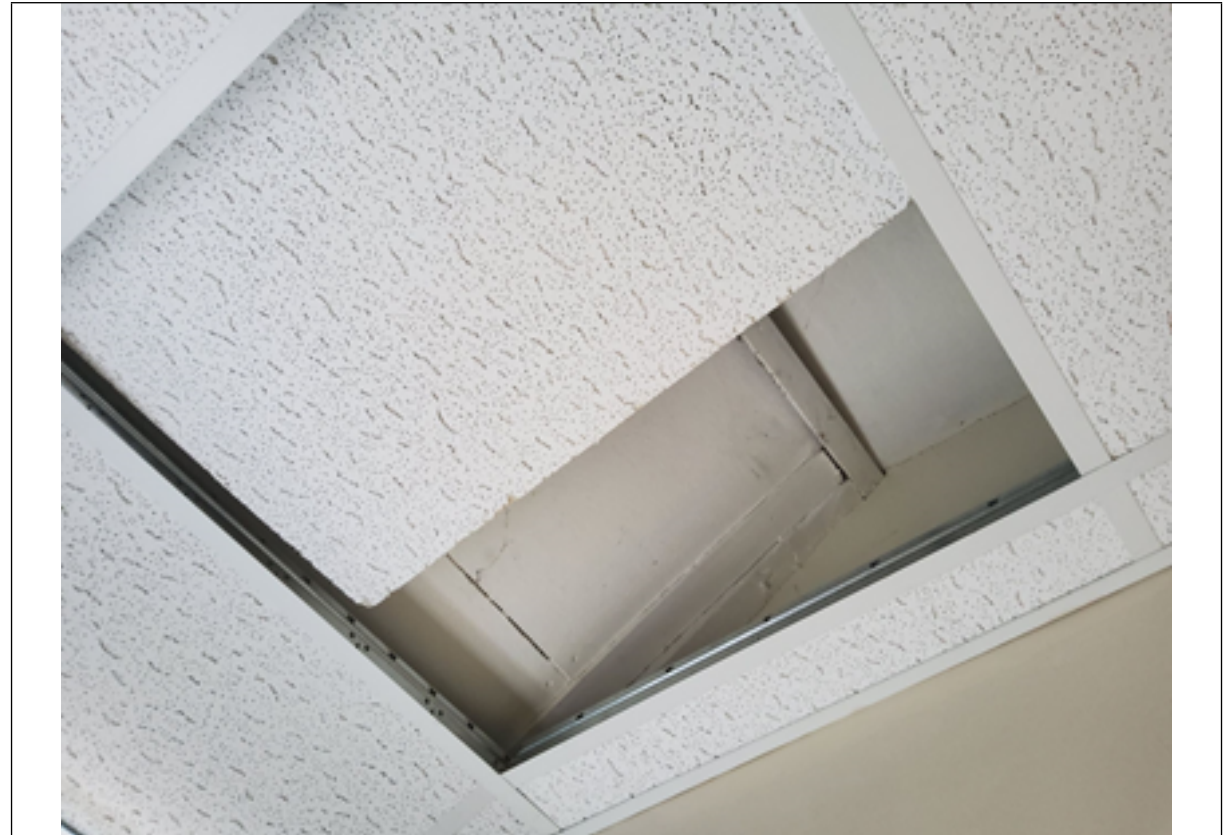
004

Asbestos Type	NADIS
Product Type	Insulation Board MMMF
Condition	No Visible Damage
Quantity	200 m2
Surface Treatment	Insulation (0)
Material Risk Score	N/A

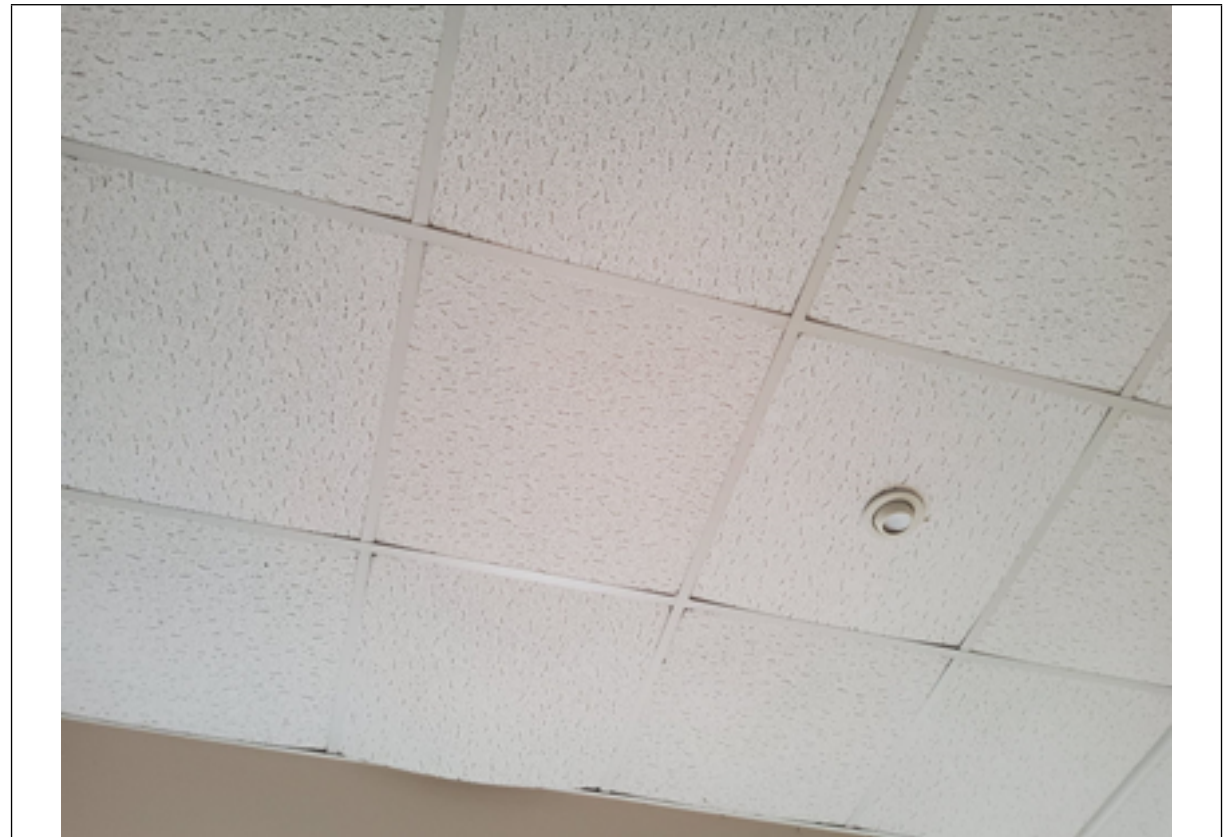
005

Asbestos Type	NADIS
Product Type	Ceiling Tiles - MMMF
Condition	Low Damage
Quantity	0 Not Applicable
Surface Treatment	Insulation (0)
Material Risk Score	N/A

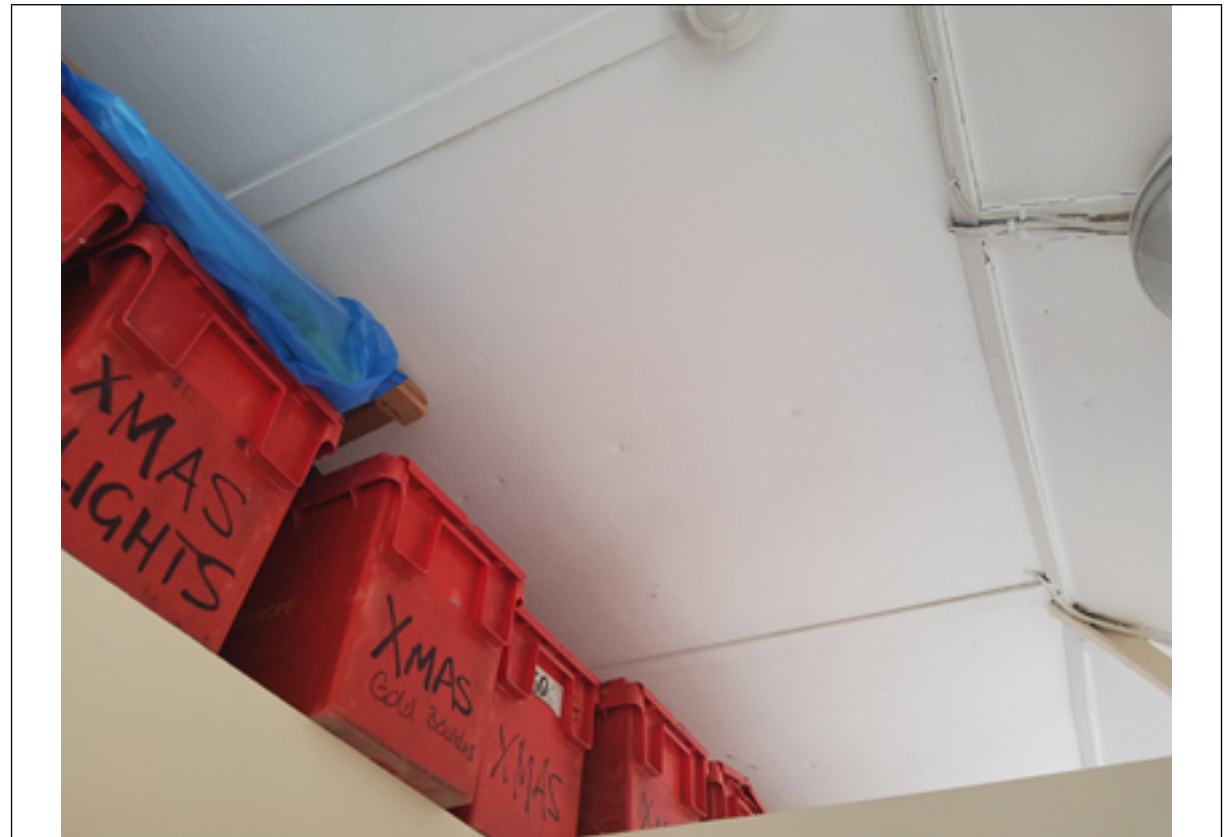
006

Asbestos Type	NADIS
Product Type	Ceiling Panels - Insulation
Condition	No Visible Damage
Quantity	0 Not Applicable
Surface Treatment	Insulation (0)
Material Risk Score	N/A

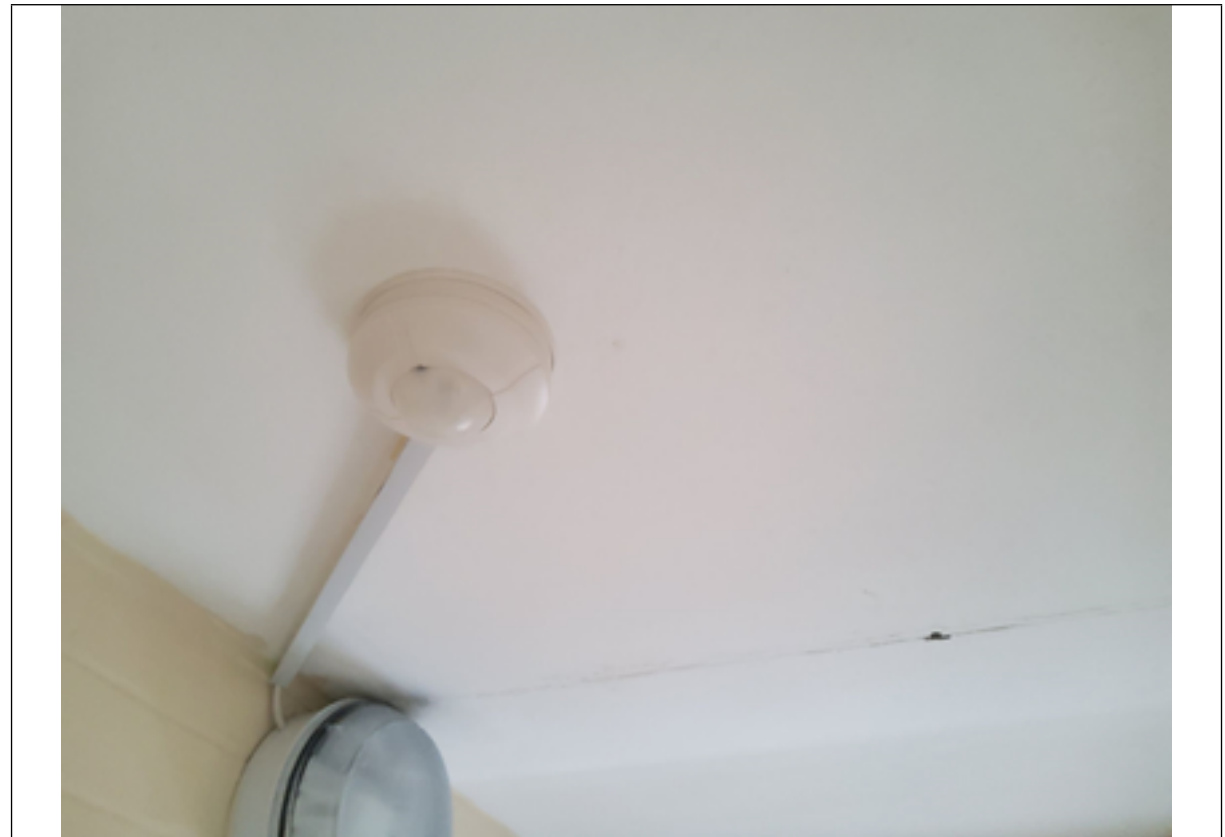
007

Asbestos Type	NADIS
Product Type	Cement Board
Condition	No Visible Damage
Quantity	2 m2
Surface Treatment	Cement
Material Risk Score	N/A

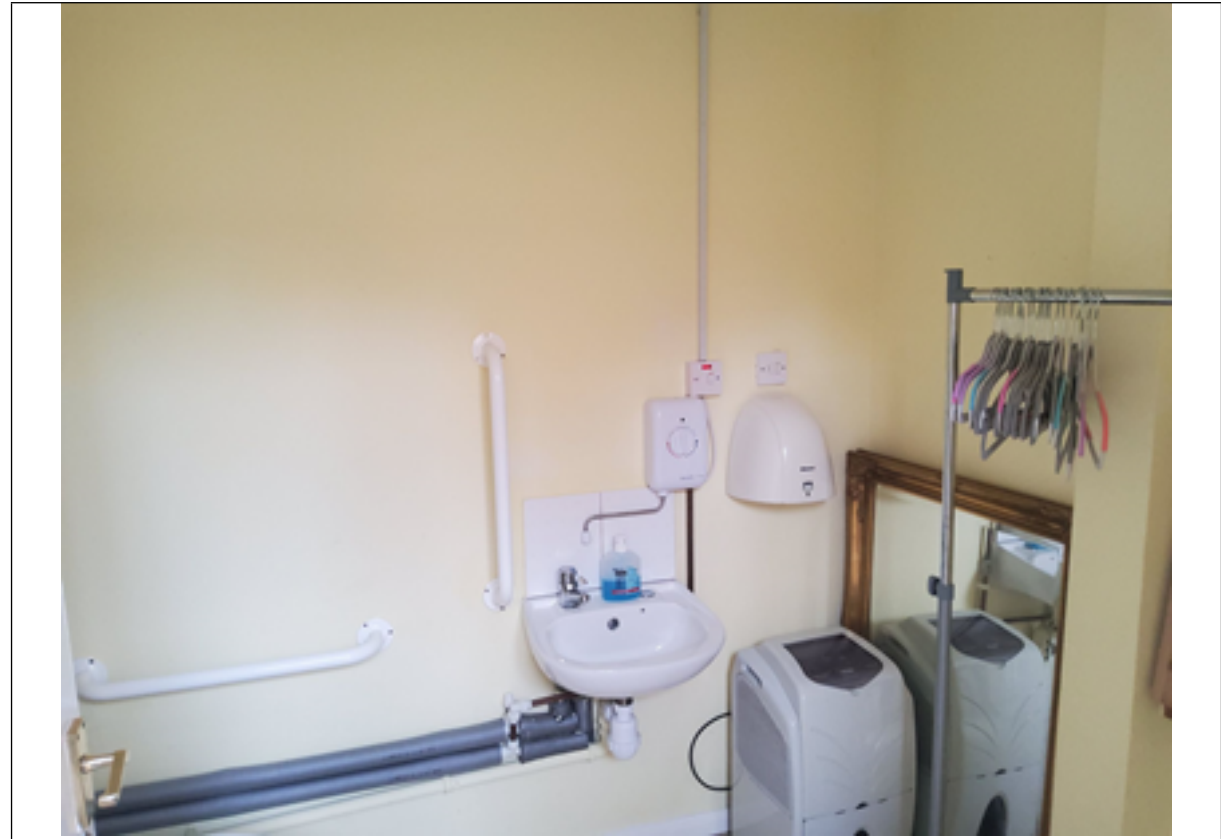
Building	Glatton Village Hall
Floor	Ground
Room	Disabled W.C.

Surveyor's Comments
This room was inspected and no suspected ACM's found

NO ASBESTOS WAS VISUALLY IDENTIFIED
