Glatton Hall and Roundhill Farms, Glatton 1991

Report No 26

The Archaeological Assessment for Glatton Hall and Roundhill Farms, Glatton.

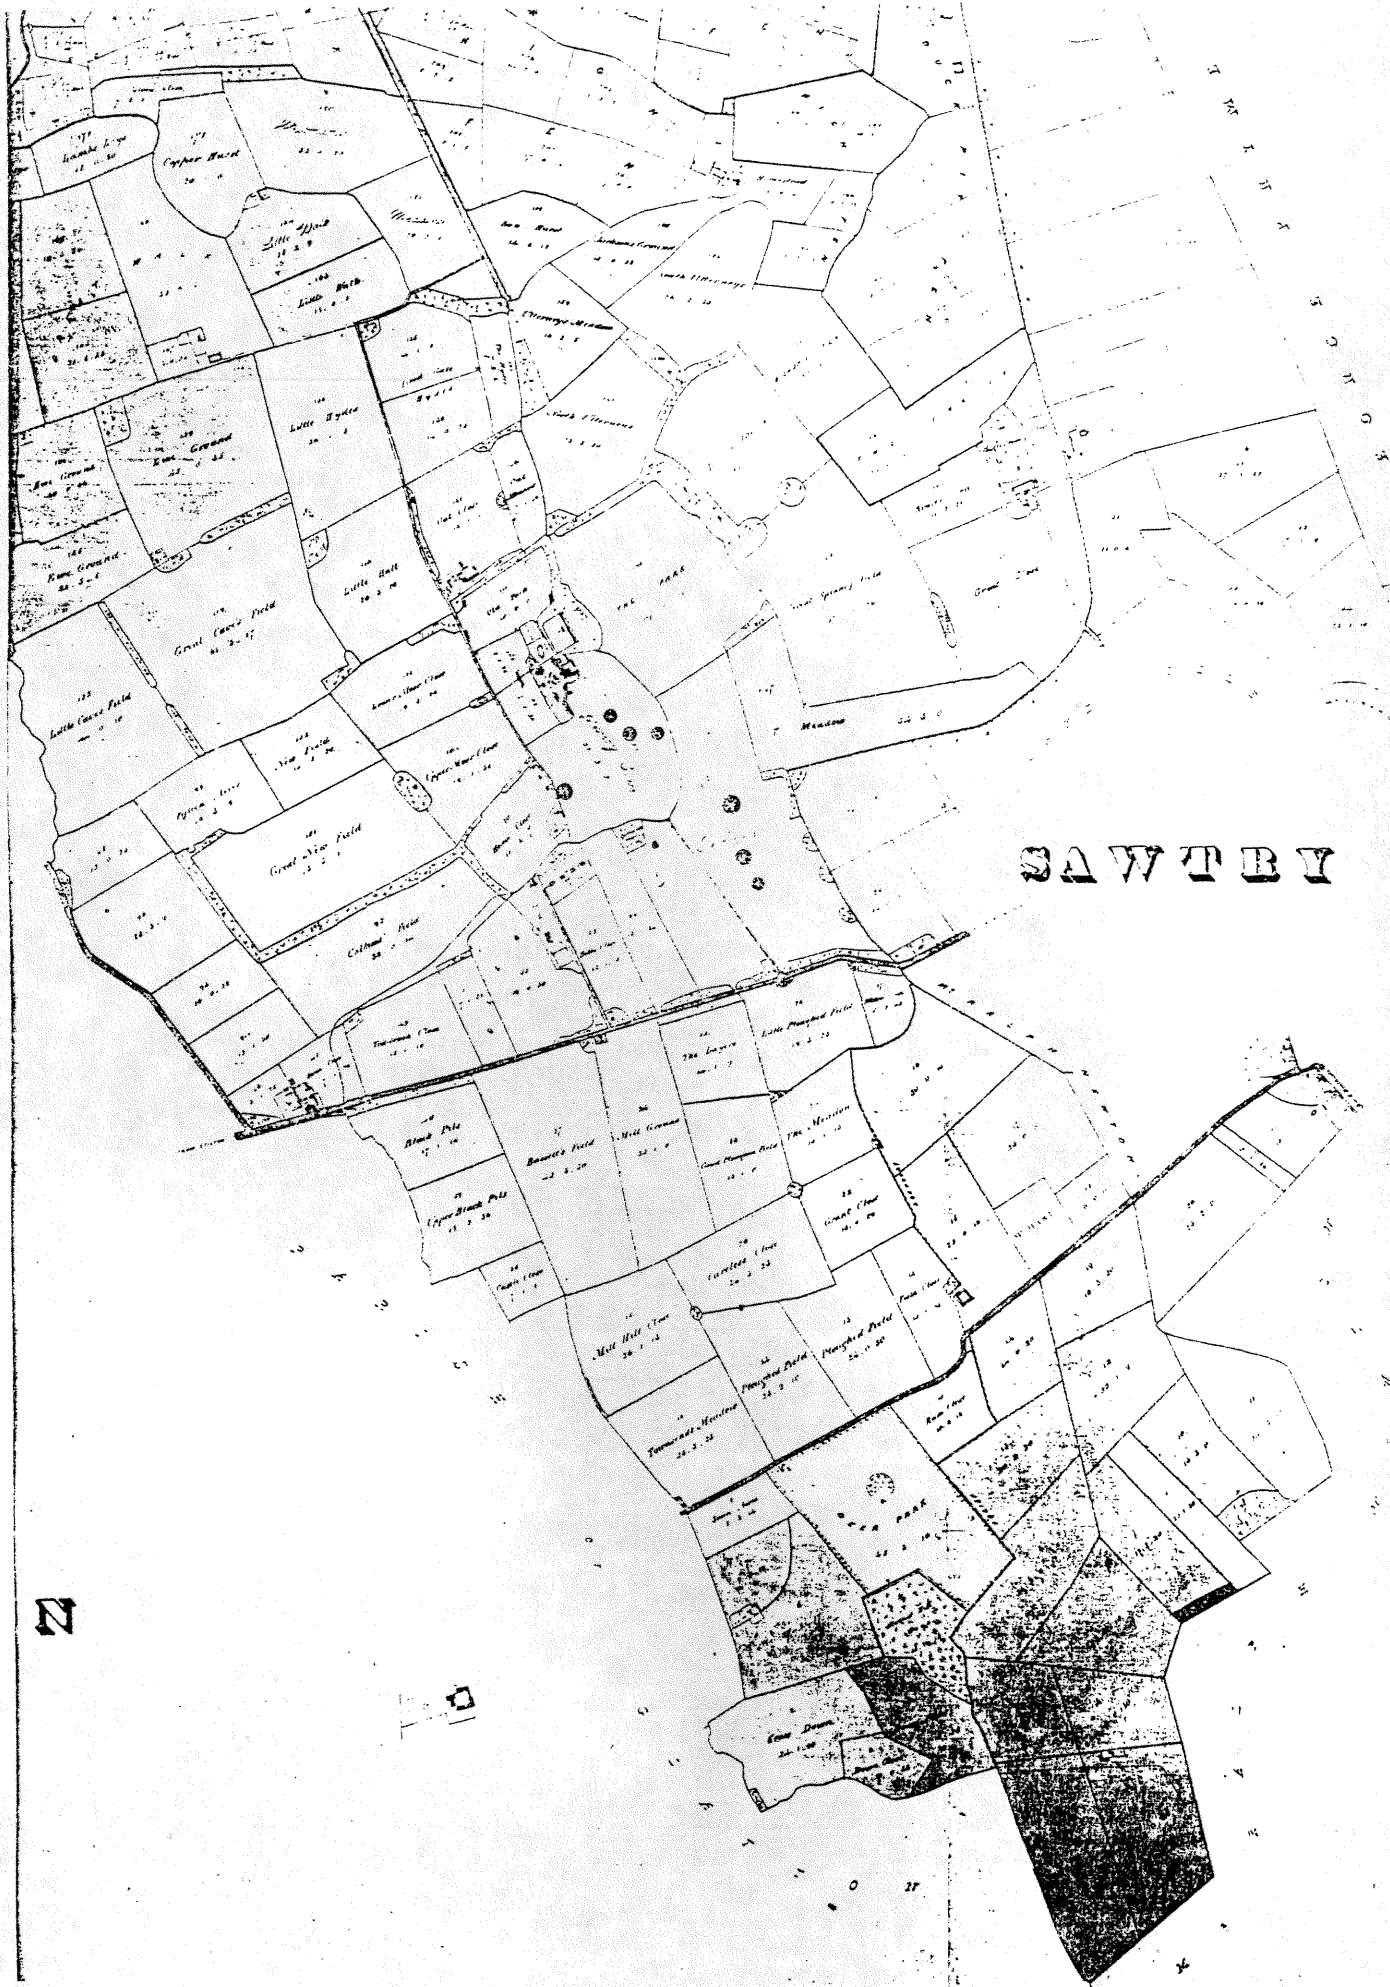
Map 3
Mr. J. M. Heathcotes Estate Map. 1847

The Ordnance Survey 2" map of the area, dated 1817, defines an area immediately to the east of Roundhill as an area of enclosed land or park, and both the First edition 1/2500 and a map of the Heathcotes estate dated 1847 (Map 3) show the remnants of what may have been a circular wood within the centre of the park, demarcated by trees.
